Inspection Report

123 Hokie Ave
Virginia Tech MD

Viking Inspections

Type of building: Single Family (2 story w/ basement)	In Attendance: Buyer and Buyers Agent	Approx. Date of Construction: 1942
Square Footage: 1660	Occupancy: Vacant	Temperature: 43 Degrees (F)
Weather: Clear	Ground/Soil surface condition: Dry	Rain in last 3 days: Unknown
Radon Test: Yes	Water Test: No

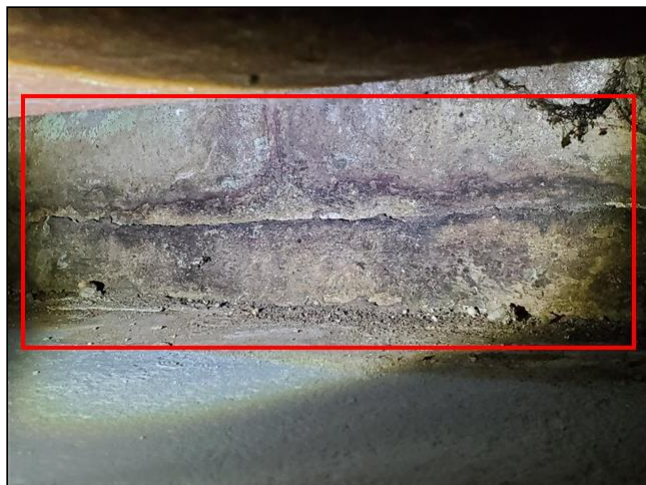
1.0 Item 1(Picture)

There is a microbial growth on the foundation wall paint, along the bottom of right foundation wall. Recommend licensed mold remediation contractor evaluate and treat/remediate as needed for health safety. Recommend installing de-humidifier in the basement to help reduce moisture and condensation on building components.

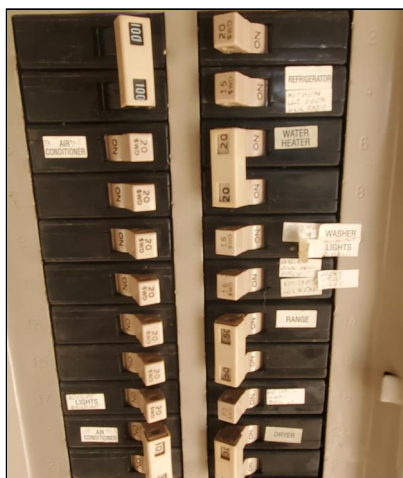
2.1 Item 2(Picture)

- (1) The main electrical service panel is located on the back exterior of the home. Common for date of construction. Recommend panel be relocated inside upon replacement.
- (2) The main electrical service panel schedule is incomplete, not all breakers are labeled. Recommend all breakers be labeled.

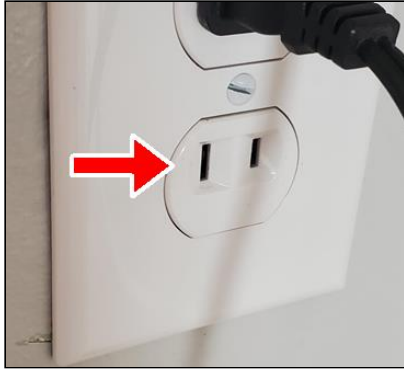
2.3 Item 4(Picture)

(4) Many of the outlets in the home are two prong ungrounded and three prong ungrounded outlets. Common for date of construction. Recommend MD licensed electrician upgrade as needed for safety enhancement.

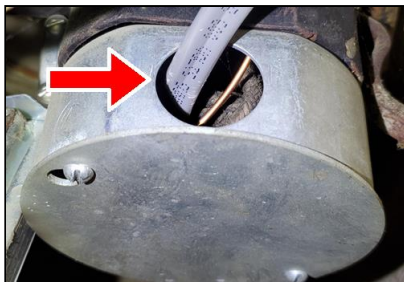
2.3 Item 5(Picture)

(5) Junction box on basement utility room ceiling is missing wire clamp/connector. Potential to damage wire. Recommend proper connector be installed for safety.

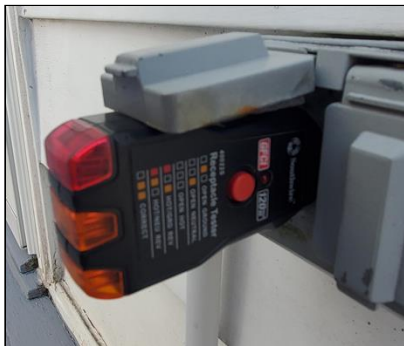
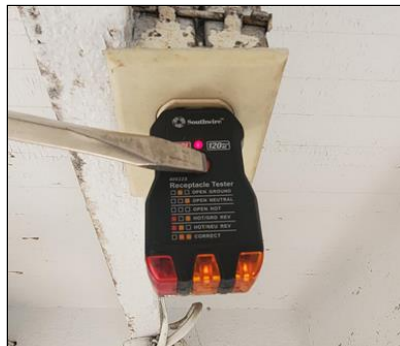
(6) The back exterior outlet at the deck is not GFCI protected. The back exterior outlet under the deck is not GFCI protected and missing cover. Recommend MD licensed electrician install GFCI outlets for safety enhancement.

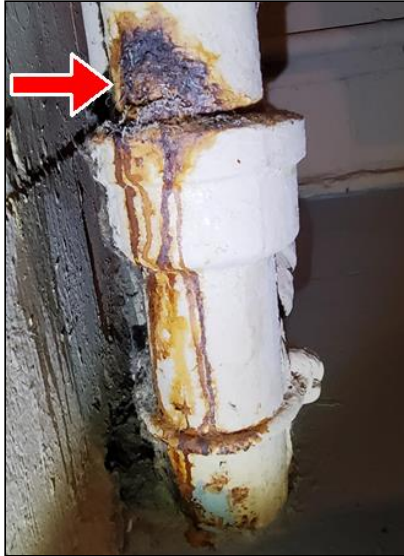
3.0 Item 1(Picture)

There is leak evidence/waste seepage on the cast iron waste pipe in the basement utility room. The cast iron waste pipe is approaching material life span. Recommend licensed plumber evaluate and repair/replace as needed.

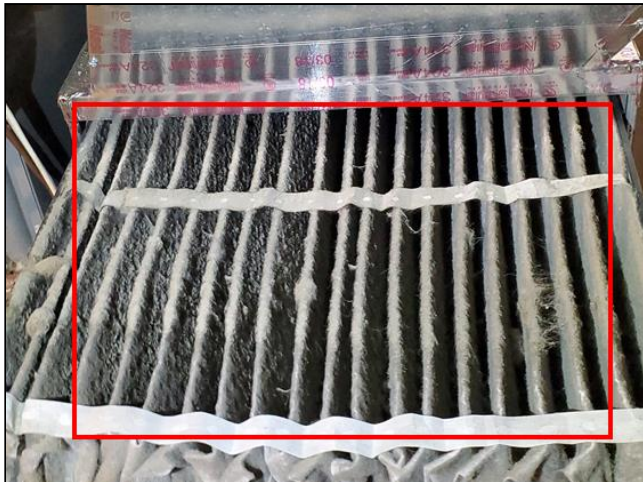
4.3 Item 1(Picture)

The HVAC air filter is past due replacement, restricting air flow. The service records indicate the furnace and air conditioner are due to be serviced. Recommend licensed HVAC contractor service systems ensuring optimal safe performance.

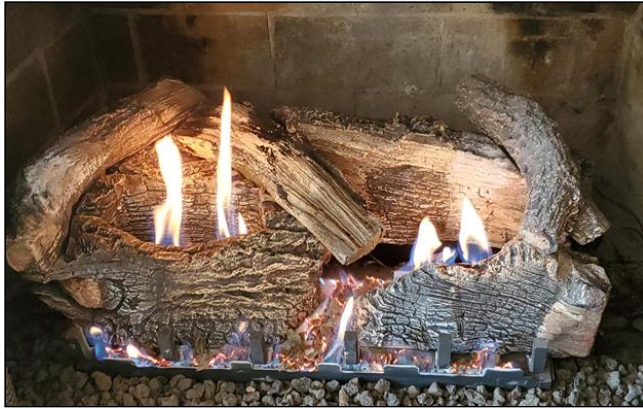
4.8 Item 1(Picture)

The propane gas fireplace insert data plate is worn, venting requirements not determined. There is no damper clamp installed on the flue damper to ensure proper opening/venting. Potential for harmful fumes (CO) to vent into the home. Recommend consulting a gas appliance contractor for evaluation prior to closing.

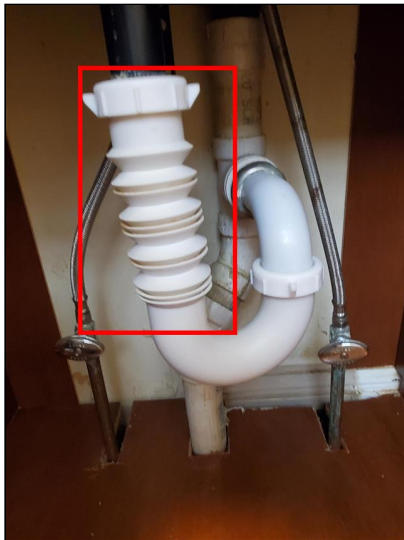
6.5 Item 1(Picture)

There is a flexible "accordion" style drain pipe installed at the half bathroom sink (minor). Potential for poor drainage/clogs. Recommend proper drain pipe be installed.

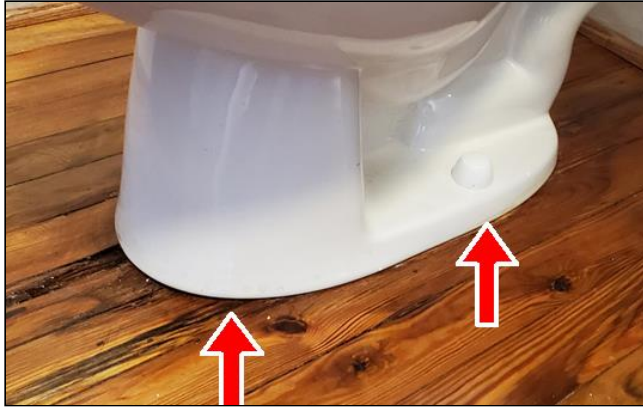
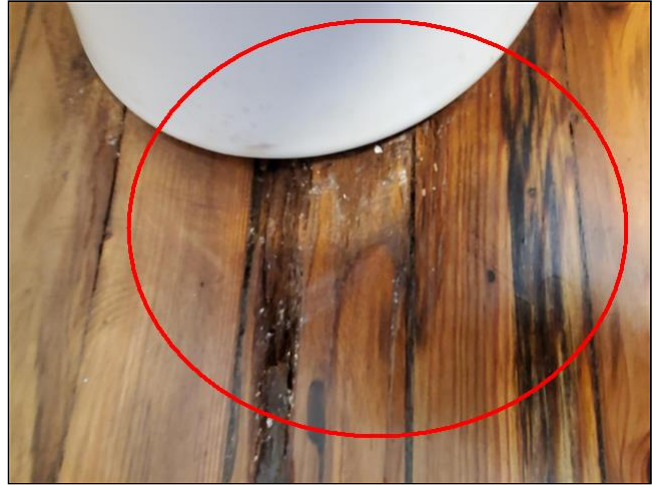
The half bathroom toilet is loose. There is water damage on the wood flooring around the toilet. The condition of the wax ring and flange are not visible. Recommend licensed plumber evaluate and repair/re-secure as needed.

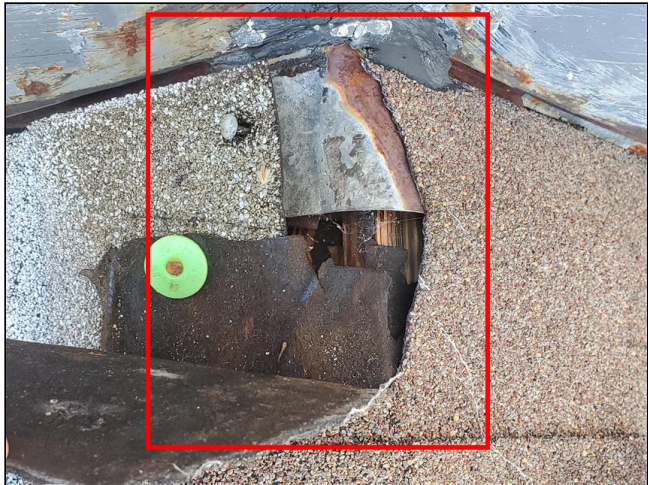
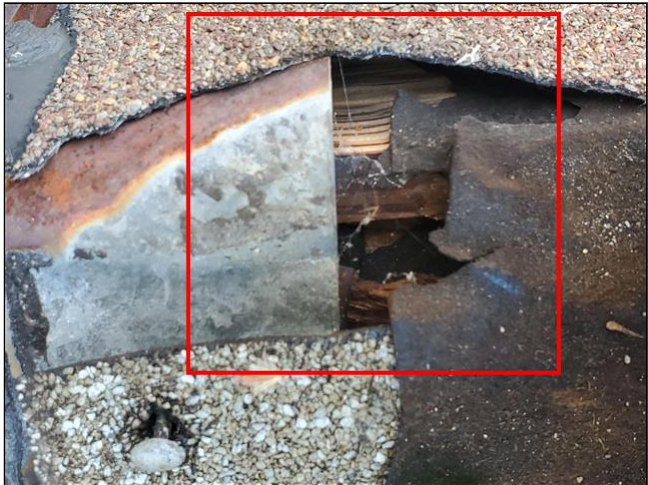
- (1) There is a damaged roof shingle and hole in the roof at the ridge next to the chimney. Recommend licensed roofer evaluate and repair/replace as needed.

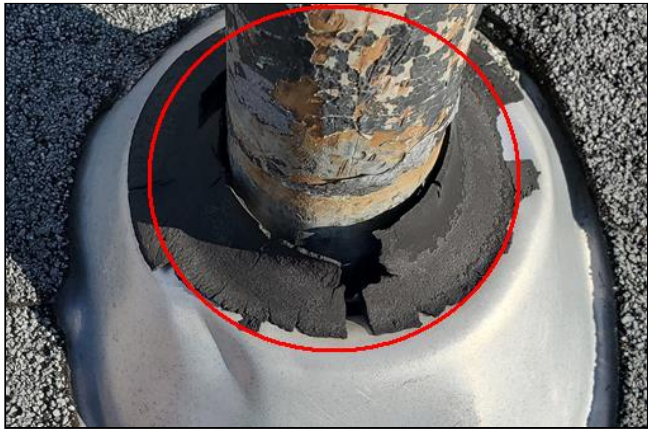
9.3 Item 1(Picture)

The back left plumbing vent boot collar is damaged and leaking. The ridge vent cap is separating from the roof, potential water penetration area. Recommend licensed roofer evaluate and repair/replace as needed.

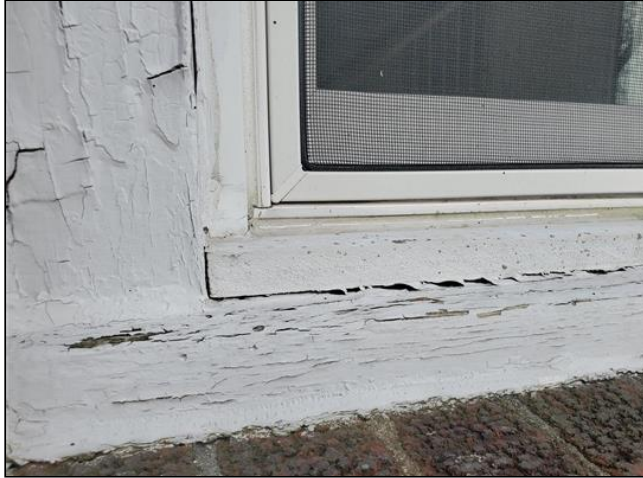
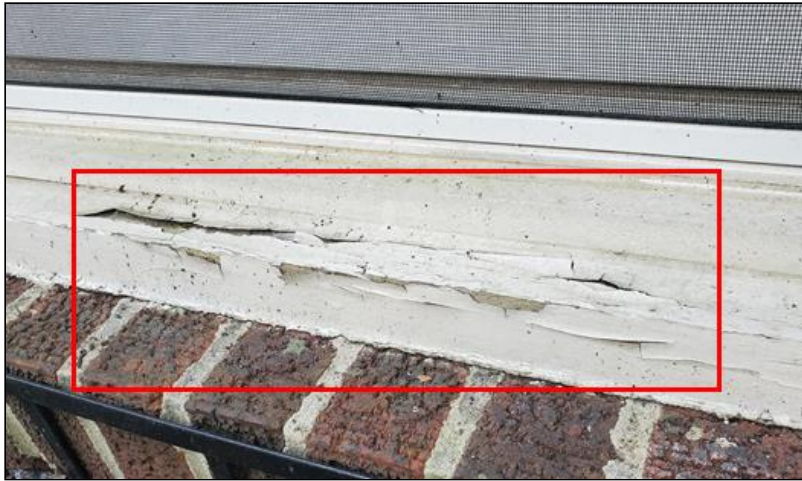
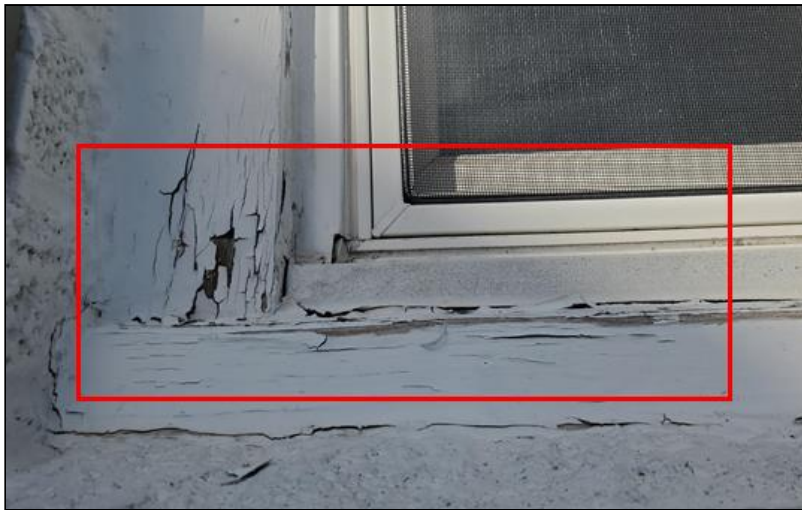
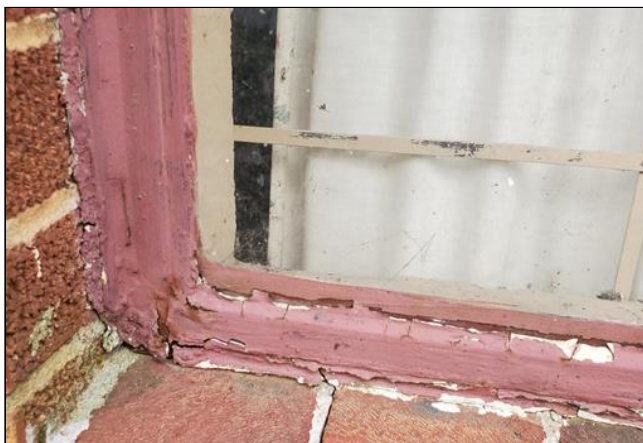
(1) There is cracking, chipping, and peeling paint on many of the exterior window frames/trim. Potential lead based paint due to age of construction. Recommend licensed contractor prep and paint as needed for preservation.

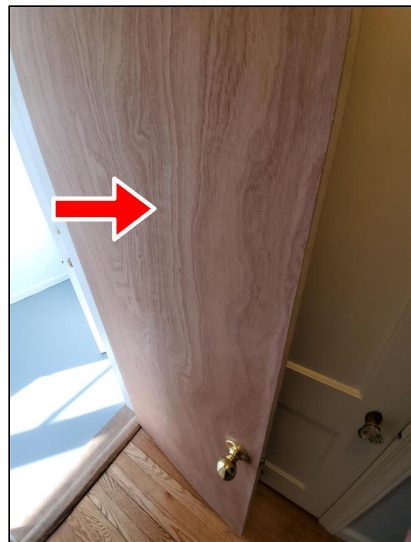
11.1 Item 1(Picture)

There is a interior rated hollow core door installed at the entrance to the covered porch/florida room. Recommend exterior rated insulated door be installed for optimal efficiency.

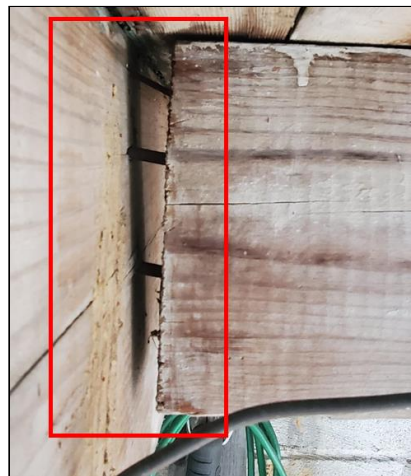
11.4 Item 1(Picture)

The deck joists under the finished patio have no hangers installed. The joists are separating from the beams/rim joists. The rim joists are secured to the posts using nails, bolts are recommended. The deck and stairwell railings are insufficient heights. Stairwell railing is approx. 26-28" high. The deck railing is approx. 35" high. Recommend licensed building construction contractor evaluate the deck and repair/replace as needed for safety.

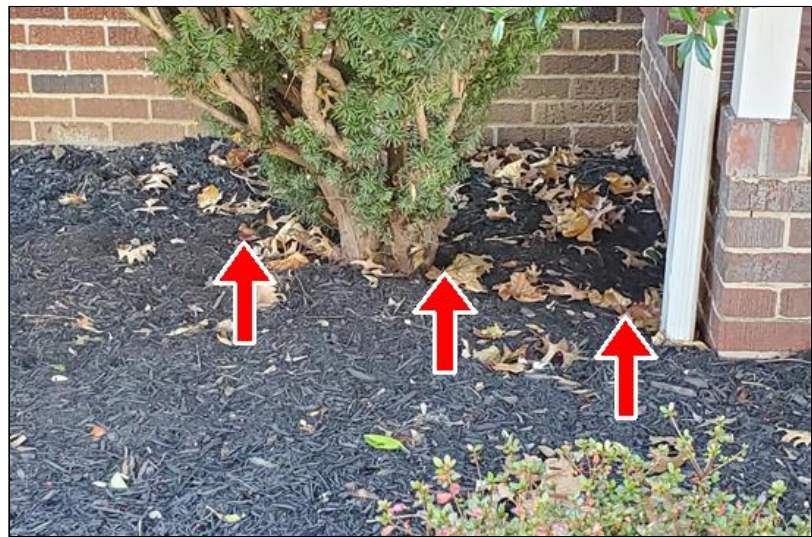
12.0 Item 1(Picture)

There is level grading in the mulch/soil along the front left side of the home. Potential for water to drain against and penetrate the foundation. Recommend grading be improved as needed to slope and drain water away from the foundation.

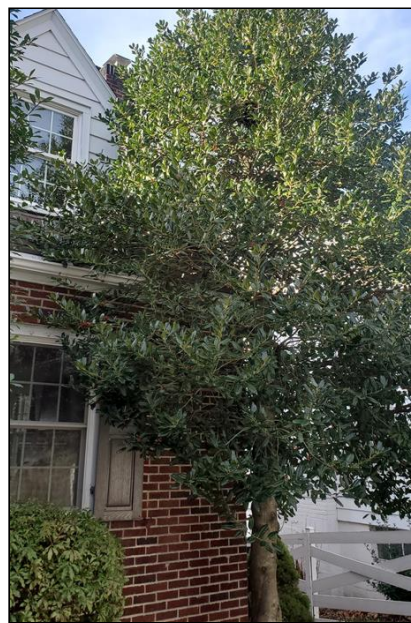
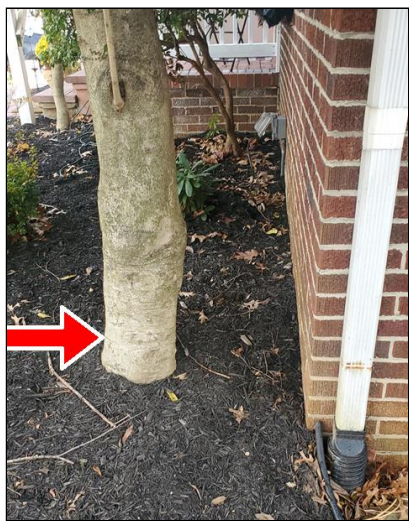
There is a tree growing against the front right corner of the home. Potential for mechanical, moisture, and pest related damage to roof and structure. Recommend licensed landscape contractor evaluate and remove/trim as needed.

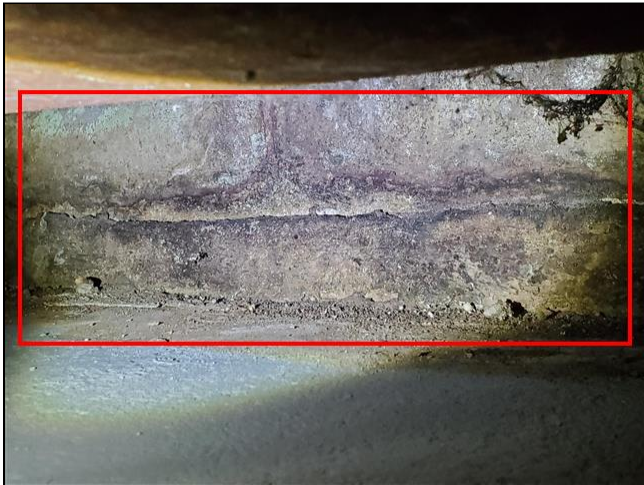
1.0 Item 1(Picture)

1.0 There is a microbial growth on the foundation wall paint, along the bottom of right foundation wall. Recommend licensed mold remediation contractor evaluate and treat/remediate as needed for health safety. Recommend installing de-humidifier in the basement to help reduce moisture and condensation on building components.

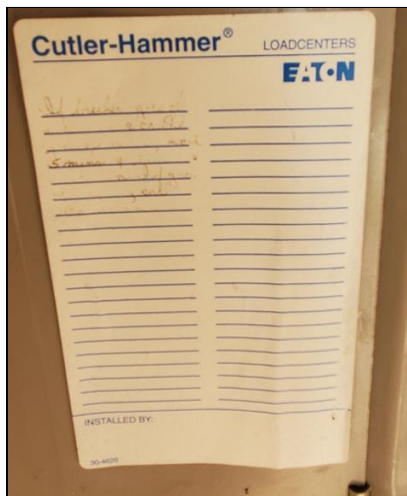
2.1 Item 1(Picture)

2.1 (1) The main electrical service panel is located on the back exterior of the home. Common for date of construction. Recommend panel be relocated inside upon replacement.

(2) The main electrical service panel schedule is incomplete, not all breakers are labeled. Recommend all breakers be labeled.

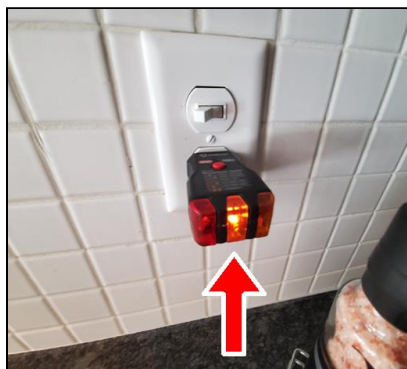
2.3 Item 1(Picture)

2.3 (1) The kitchen outlets are not grounded or GFCI protected. Common for date of construction. Recommend MD licensed electrician install grounded GFCI outlets for safety enhancement.

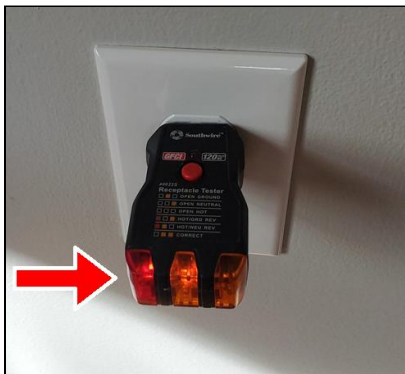
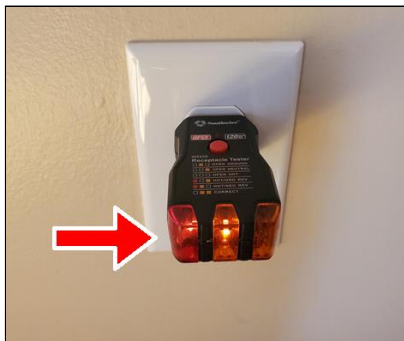
(3) A outlet in the living room and front left bedroom have reversed hot and neutral wires. Recommend MD licensed electrician repair for safety.

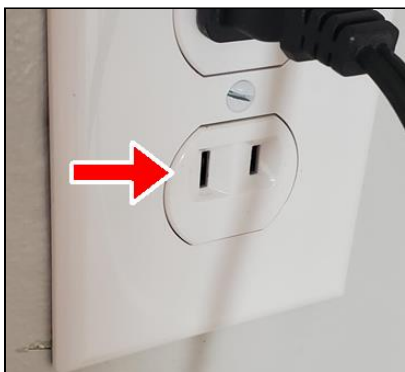
2.3 Item 4(Picture)

(4) Many of the outlets in the home are two prong ungrounded and three prong ungrounded outlets. Common for date of construction. Recommend MD licensed electrician upgrade as needed for safety enhancement.

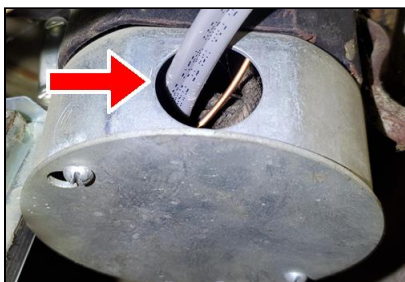
2.3 Item 5(Picture)

(5) Junction box on basement utility room ceiling is missing wire clamp/connector. Potential to damage wire. Recommend proper connector be installed for safety.

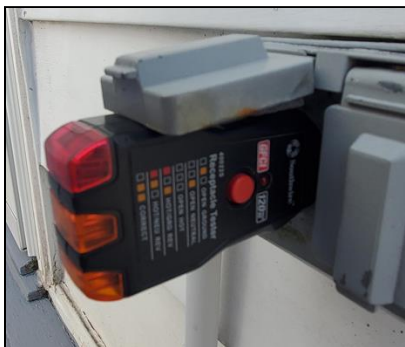
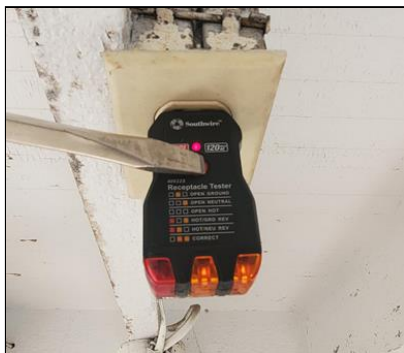
(6) The back exterior outlet at the deck is not GFCI protected. The back exterior outlet under the deck is not GFCI protected and missing cover. Recommend MD licensed electrician install GFCI outlets for safety enhancement.

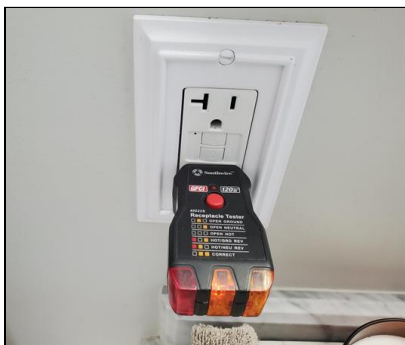
2.4 Item 1(Picture)

2.4 The top floor bathroom GFCI outlet is not grounded. Common for date of construction. Recommend MD licensed electrician ground for safety enhancement.

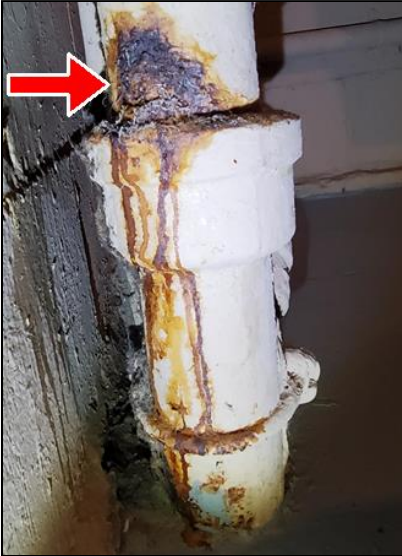
3.0 Item 1(Picture)

3.0 There is leak evidence/waste seepage on the cast iron waste pipe in the basement utility room. The cast iron waste pipe is approaching material life span. Recommend licensed plumber evaluate and repair/replace as needed.

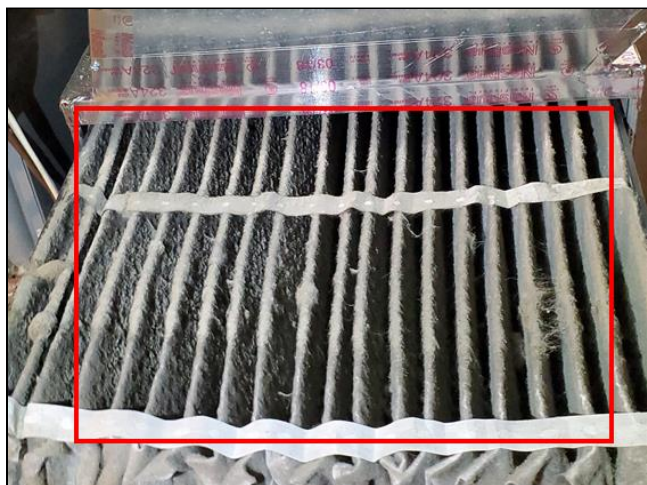
4.3 Item 1(Picture)

4.3 The HVAC air filter is past due replacement, restricting air flow. The service records indicate the furnace and air conditioner are due to be serviced. Recommend licensed HVAC contractor service systems ensuring optimal safe performance.

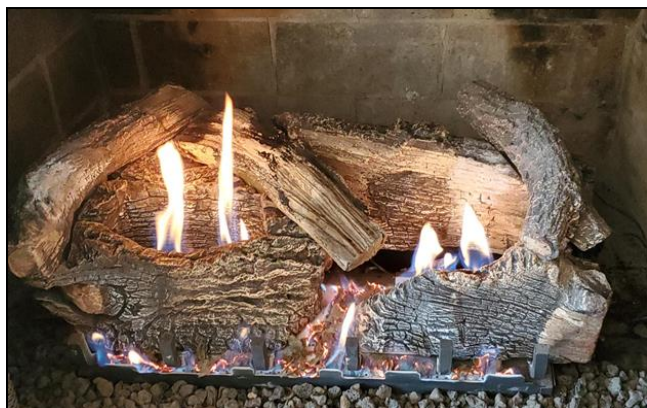
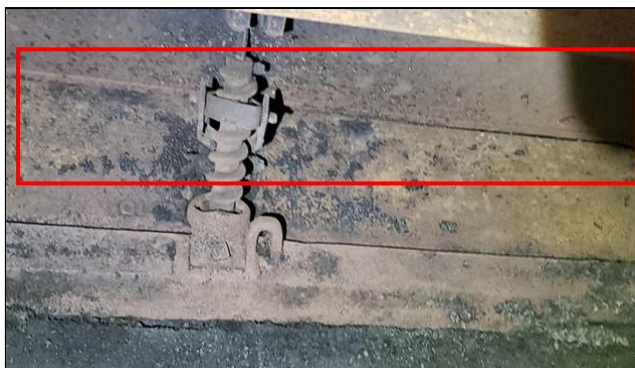
4.8 The propane gas fireplace insert data plate is worn, venting requirements not determined. There is no damper clamp installed on the flue damper to ensure proper opening/venting. Potential for harmful fumes (CO) to vent into the home. Recommend consulting a gas appliance contractor for evaluation prior to closing.

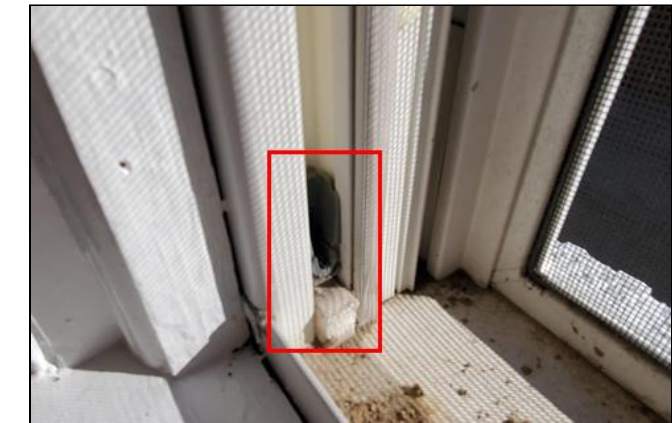
5.4 Item 1(Picture)

5.4 The kitchen window lower sash balance is disconnected (minor). The window slams shut when opened. Recommend sash balance be re-secured for safety.

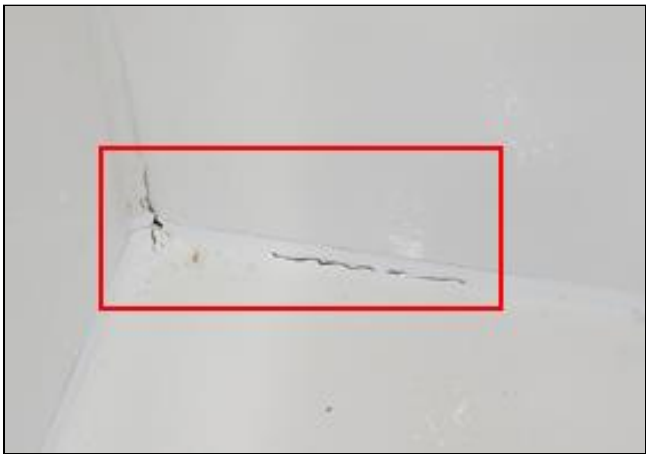
6.1 Item 1(Picture)

6.1 Separated caulking at top floor bathroom shower wall (minor). Recommend caulking be improved ensuring a water tight seal.

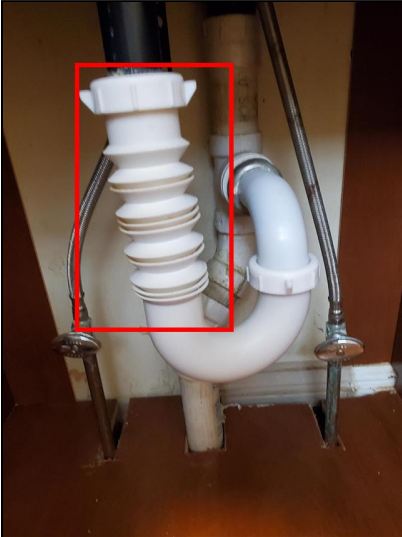
6.5 Item 1(Picture)

6.5 There is a flexible "accordion" style drain pipe installed at the half bathroom sink (minor). Potential for poor drainage/ clogs. Recommend proper drain pipe be installed.

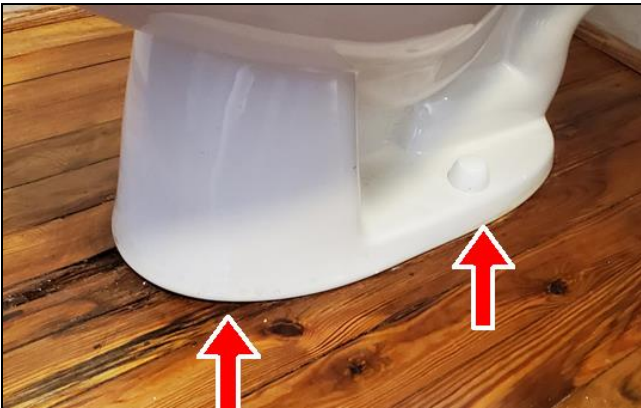
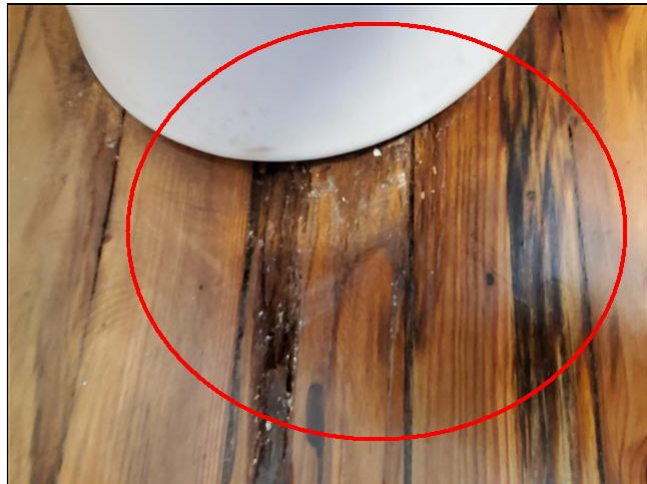
6.7 The half bathroom toilet is loose. There is water damage on the wood flooring around the toilet. The condition of the wax ring and flange are not visible. Recommend licensed plumber evaluate and repair/re-secure as needed.

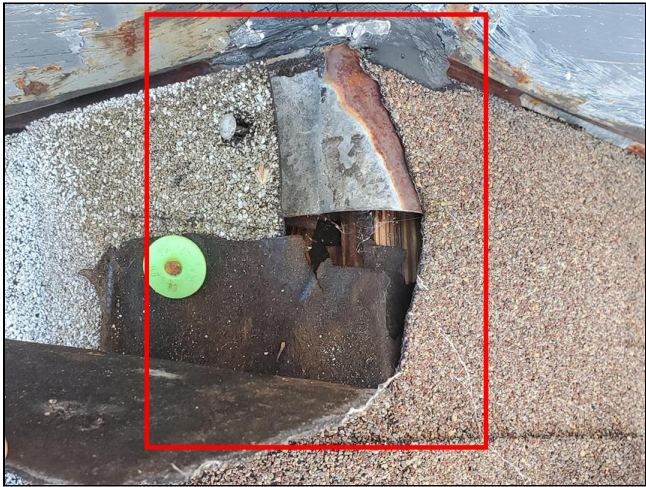
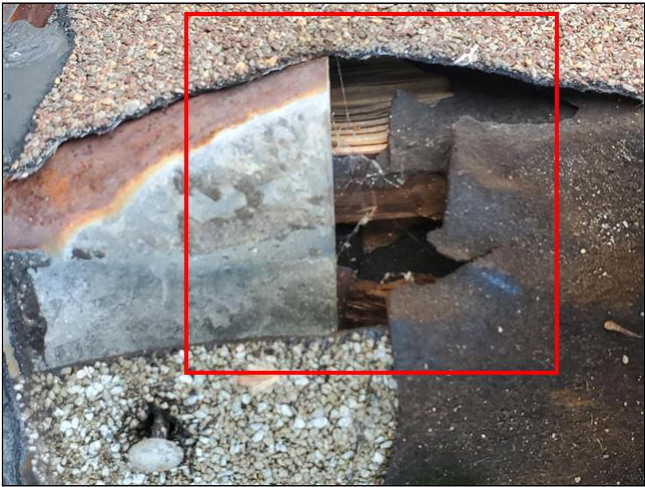
9.0 (1) There is a damaged roof shingle and hole in the roof at the ridge next to the chimney. Recommend licensed roofer evaluate and repair/replace as needed.

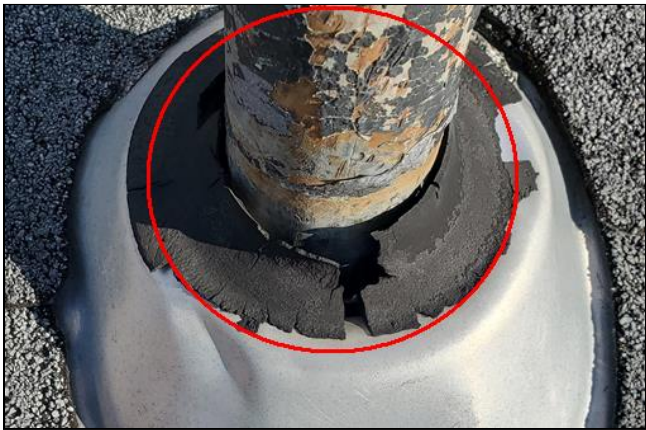
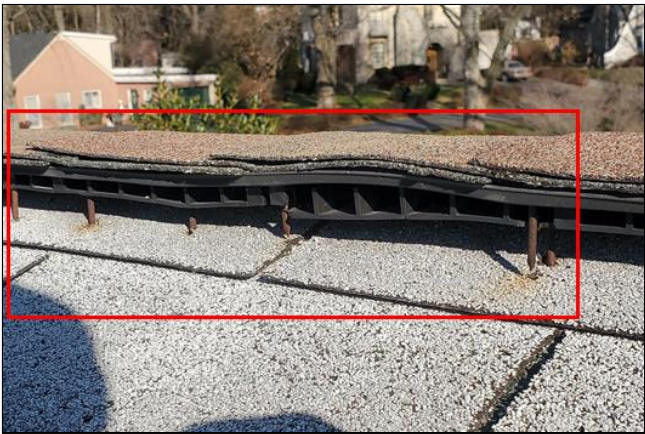
9.3 Item 1(Picture)

9.3 The back left plumbing vent boot collar is damaged and leaking. The ridge vent cap is separating from the roof, potential water penetration area. Recommend licensed roofer evaluate and repair/replace as needed.

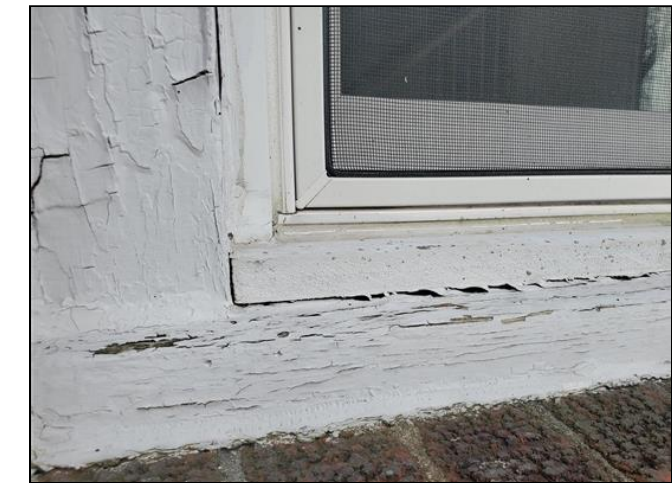
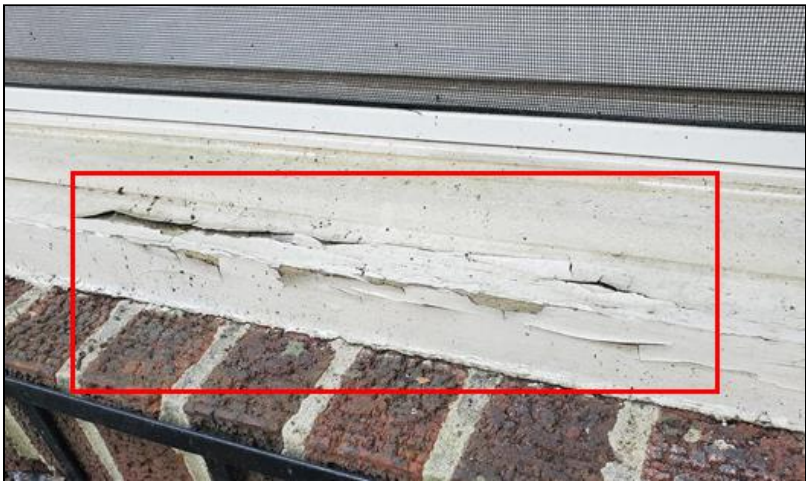
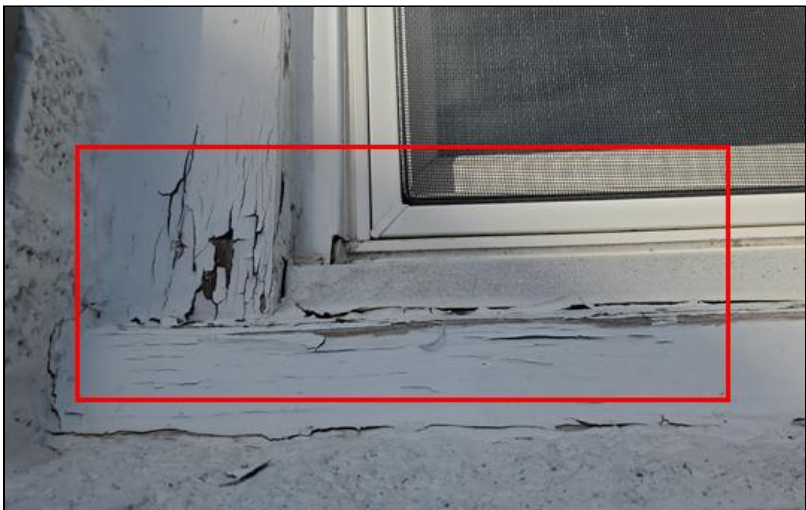
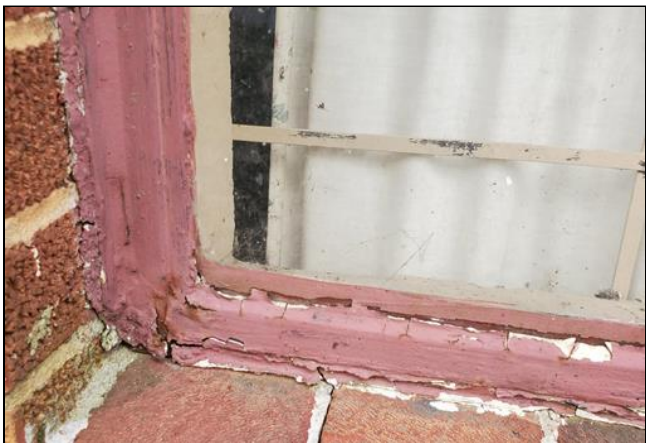
11.0 (1) There is cracking, chipping, and peeling paint on many of the exterior window frames/trim. Potential lead based paint due to age of construction. Recommend licensed contractor prep and paint as needed for preservation.

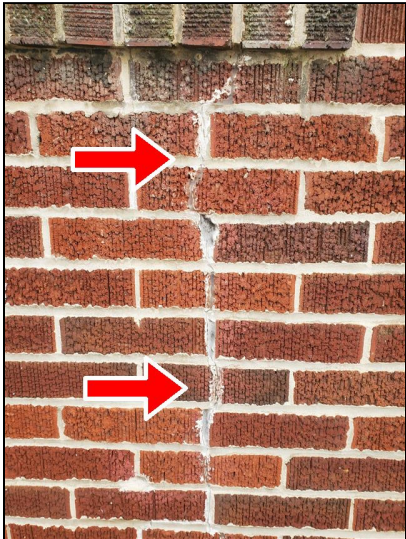
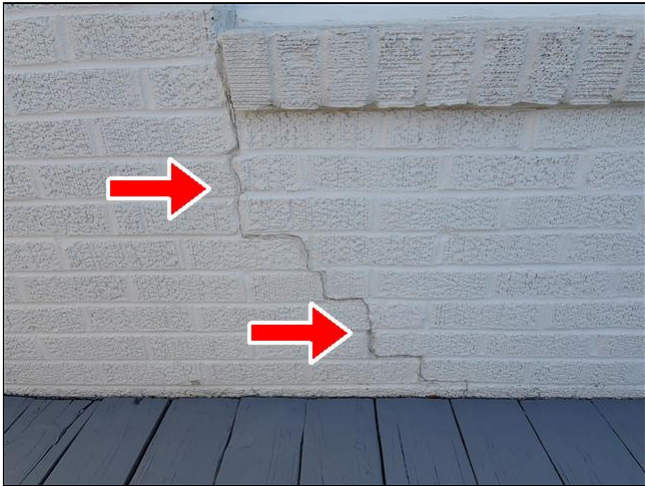
(2) There are several cracked mortar joints in the exterior brick veneer, below window sills. The cracked mortar joints have been sealed. Recommend monitoring, maintain seal to prevent water penetration "spalling". Budget for re-pointing.

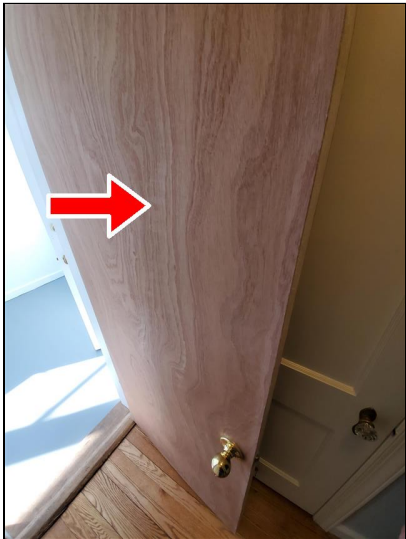
11.1 Item 1(Picture)

11.1 There is a interior rated hollow core door installed at the entrance to the covered porch/florida room. Recommend exterior rated insulated door be installed for optimal efficiency.

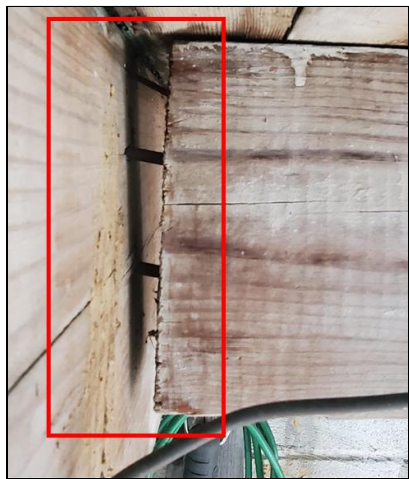
11.4 Item 1(Picture)

11.4 The deck joists under the finished patio have no hangers installed. The joists are separating from the beams/rim joists. The rim joists are secured to the posts using nails, bolts are recommended. The deck and stairwell railings are insufficient heights. Stairwell railing is approx. 26-28" high. The deck railing is approx. 35" high. Recommend licensed building construction contractor evaluate the deck and repair/replace as needed for safety.

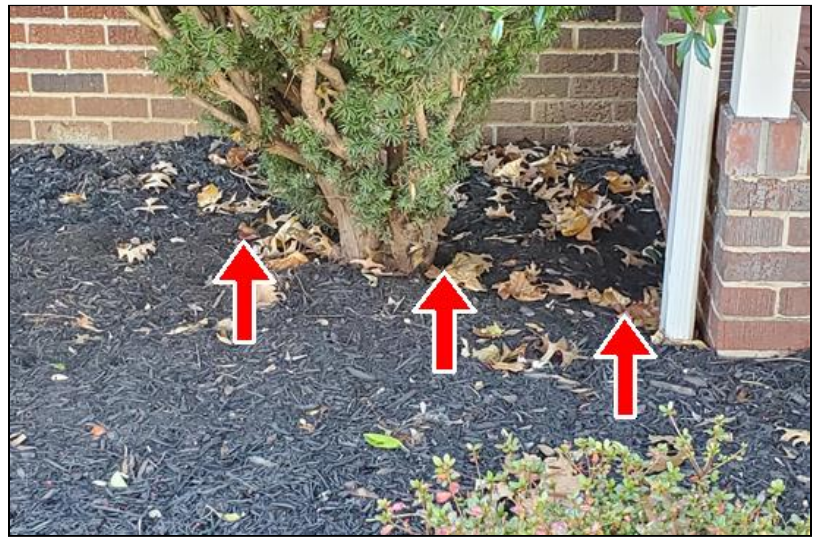
12.0 Item 1(Picture)

12.0 There is level grading in the mulch/soil along the front left side of the home. Potential for water to drain against and penetrate the foundation. Recommend grading be improved as needed to slope and drain water away from the foundation.

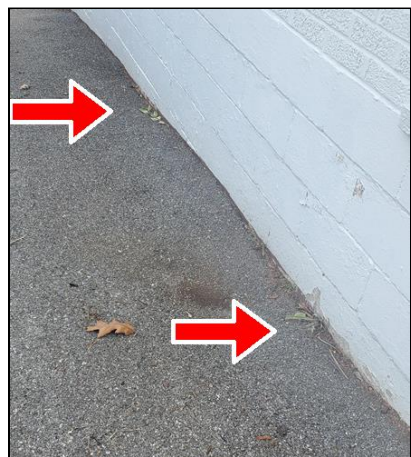
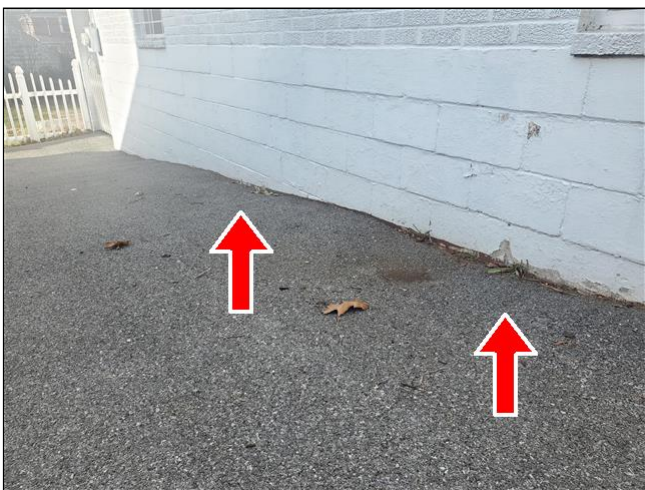
12.3 There are several low spots in the asphalt driveway along the left foundation wall. Potential for water to puddle against and penetrate the foundation. No signs of water penetration in the basement along the left foundation wall. Recommend monitoring. Budget for repairs upon driveway re-seal.

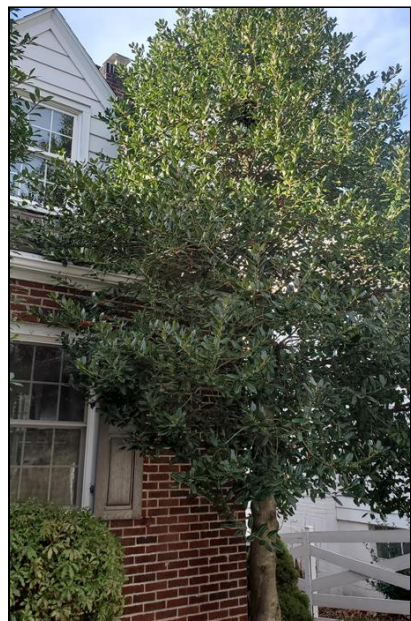
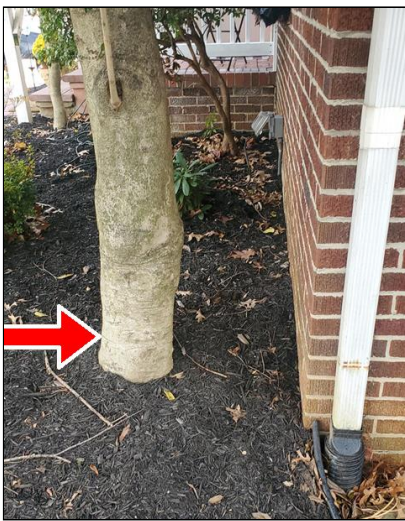
12.5 There is a tree growing against the front right corner of the home. Potential for mechanical, moisture, and pest related damage to roof and structure. Recommend licensed landscape contractor evaluate and remove/trim as needed.

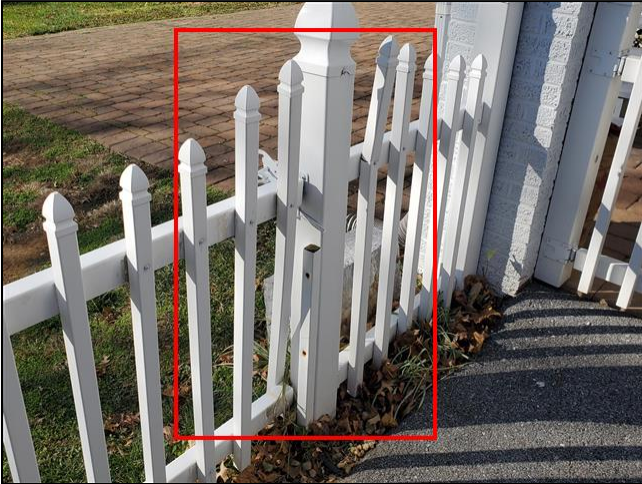
12.6 Item 1(Picture)

12.6 Several of the front left fence pickets are damaged (minor). The front left gate is difficult to open/close. The fence is in functional condition.
