## Inspection Report

**Property Address:**  
123 Virginia Tech Ave  
Blacksburg MD 21701

<b>In Attendance:</b> Owner	<b>Type of building:</b> Single Family (2 story w/ basement)	<b>Approximate age of building:</b> New Construction, Pre-drywall, 2022
<b>Temperature:</b> 55 Degrees (F)	<b>Weather:</b> Rain	<b>Ground/Soil surface condition:</b> Saturated
<b>Rain in last 3 days:</b> Yes	<b>Radon Test:</b> No	<b>Water Test:</b> No

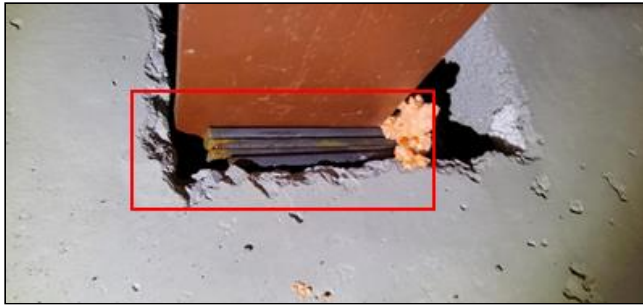
1.2 Item 1(Picture)

(1) The shims installed under the steel beams at bearing on foundation are not welded together or to the beam. Recommend shims be welded together and to beam.

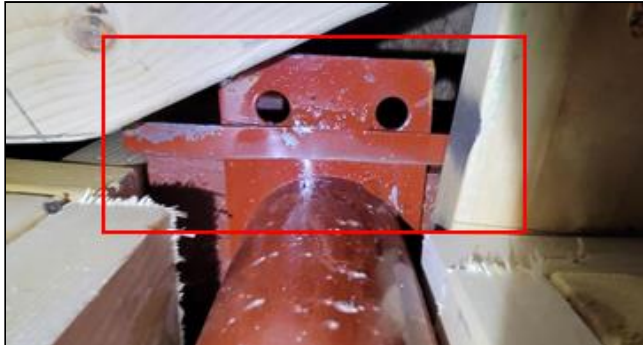
1.2 Item 3(Picture)

(2) At steel posts top plate is not strapped, bolted, or welded to the steel beam. Recommend steel post be welded to the beam.

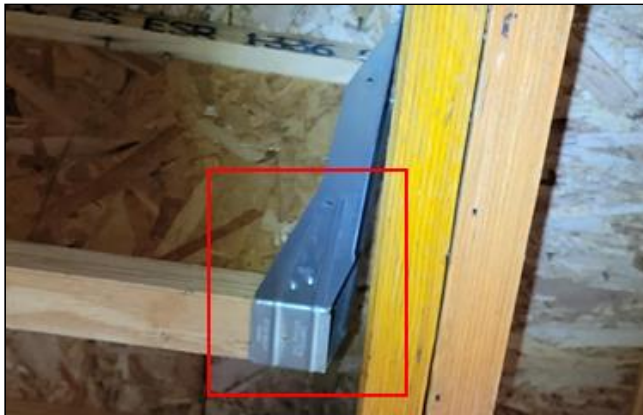
1.3 Item 1(Picture)

Several of the top level floor joists are not properly supported in the joist hangers. Insufficient bearing in hangers and separated from the support beam. Potential to effect the top level floor structure. Recommend evaluation and repair as needed.

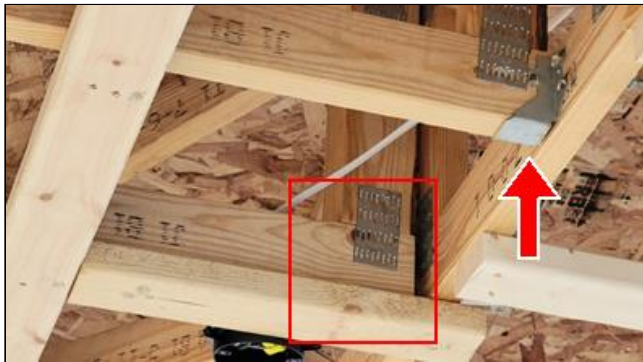
1.5 Item 1(Picture)

(1) Two porch roof trusses have no truss hangers installed. Potential to effect porch roof structure. Recommend proper hangers be installed.

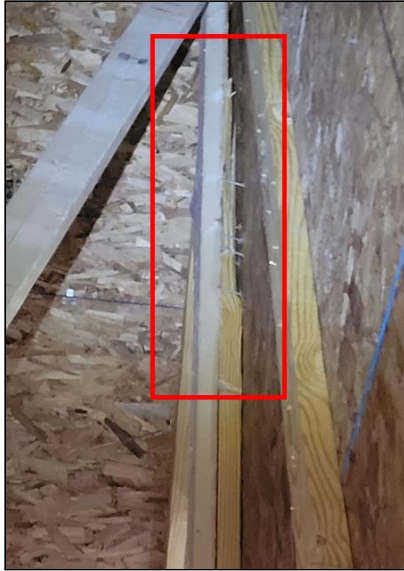
1.5 Item 3(Picture)

(2) There is a damaged roof truss web member at the front roof gable, above vaulted ceiling. There is a cracked roof truss bottom cord above the top floor front left bedroom. Insufficient repairs. Potential to effect roof structure. Recommend MD licensed structural engineer evaluate. Recommend licensed building construction contractor complete repairs per engineer.

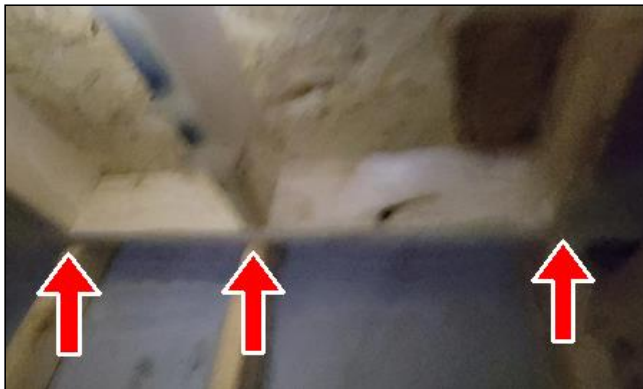
2.1 Item 1(Picture)

No floor joist hangers installed at basement stairwell landing. Floor joists at top floor stairwell landing have joist hangers installed. There is a gap basement stairwell landing rim joist and support framing. Potential to effect landing floor structure. Recommend evaluation and repair as needed.

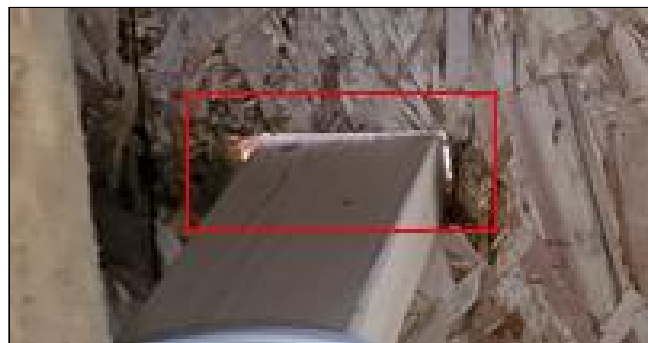
2.5 Item 1(Picture)

There are several unsealed penetrations in the subfloor. Recommend subfloor penetrations be sealed for proper air/fire stopping.

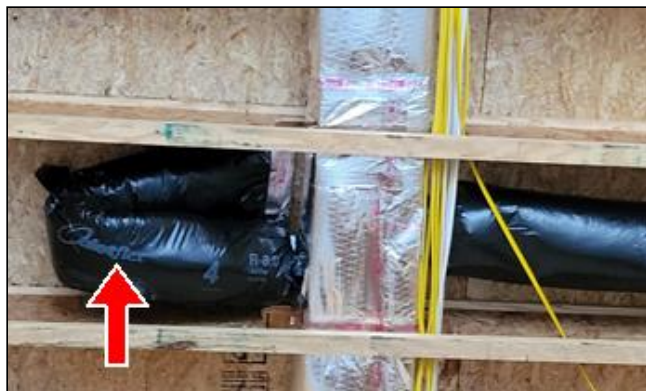
3.1 Item 1(Picture)

A HVAC supply duct in the main floor ceiling is improperly bent. Supply vents bent more than 90 degrees have potential to effect proper air flow. Recommend licensed HVAC contractor repair.

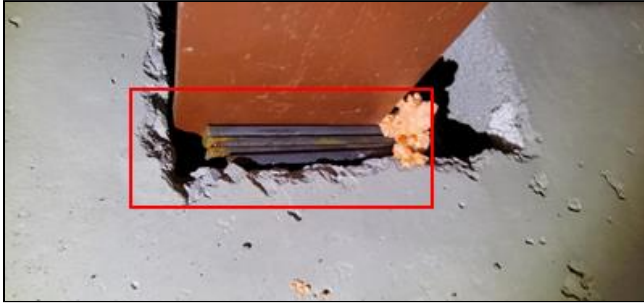
1.2 Item 1(Picture)

1.2 (1) The shims installed under the steel beams at bearing on foundation are not welded together or to the beam. Recommend shims be welded together and to beam.

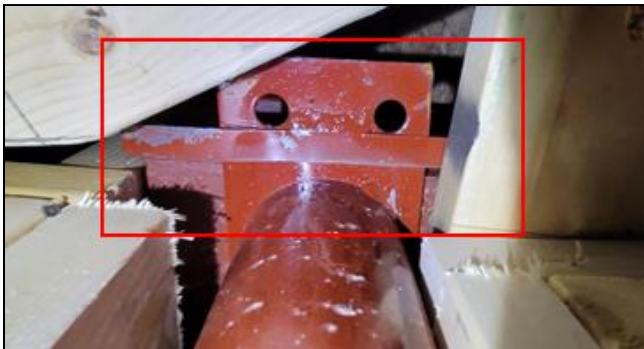
1.2 Item 3(Picture)

(2) At steel posts top plate is not strapped, bolted, or welded to the steel beam. Recommend steel post be welded to the beam.

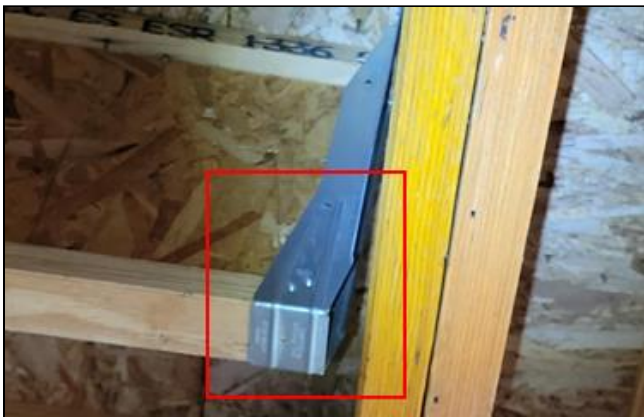
1.3 Item 1(Picture)

1.3 Several of the top level floor joists are not properly supported in the joist hangers. Insufficient bearing in hangers and separated from the support beam. Potential to effect the top level floor structure. Recommend evaluation and repair as needed.

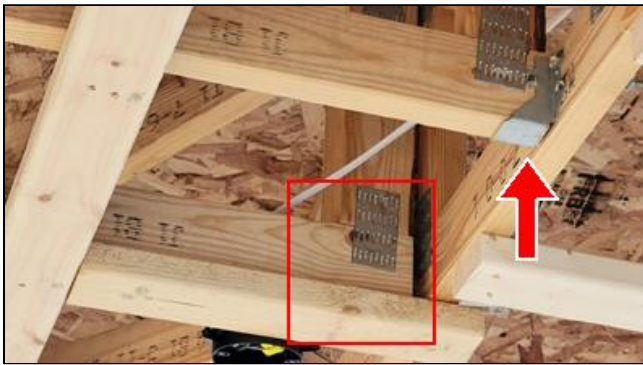
1.5 Item 1(Picture)

1.5 (1) Two porch roof trusses have no truss hangers installed. Potential to effect porch roof structure. Recommend proper hangers be installed.

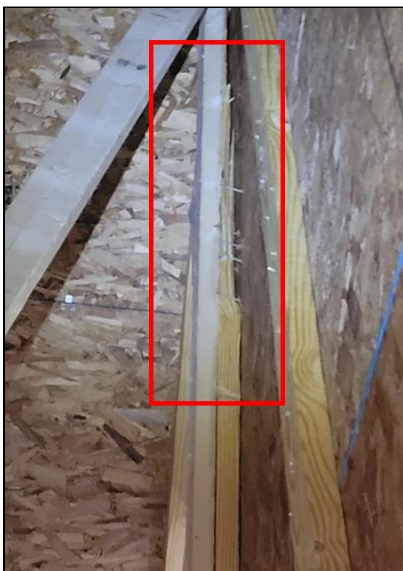
1.5 Item 3(Picture)

(2) There is a damaged roof truss web member at the front roof gable, above vaulted ceiling. There is a cracked roof truss bottom cord above the top floor front left bedroom. Insufficient repairs. Potential to effect roof structure. Recommend MD licensed structural engineer evaluate. Recommend licensed building construction contractor complete repairs per engineer.

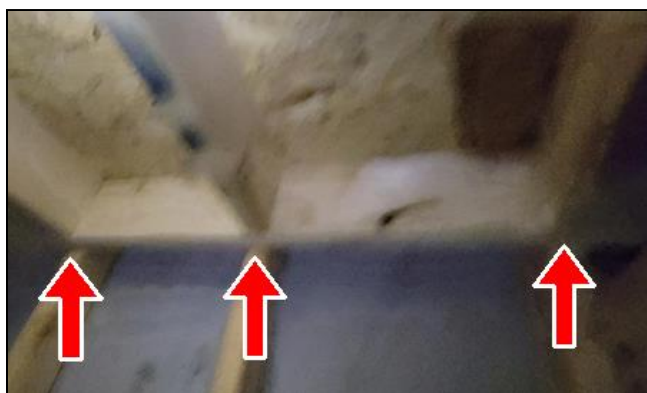
2.1 Item 1(Picture)

**2.1** No floor joist hangers installed at basement stairwell landing. Floor joists at top floor stairwell landing have joist hangers installed. There is a gap basement stairwell landing rim joist and support framing. Potential to effect landing floor structure. Recommend evaluation and repair as needed.

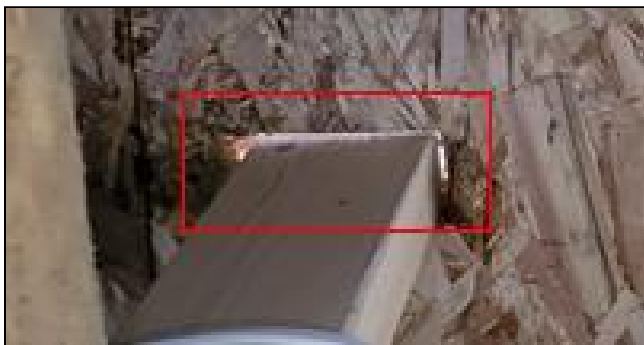
2.5 Item 1(Picture)

2.5 There are several unsealed penetrations in the subfloor. Recommend subfloor penetrations be sealed for proper air/fire stopping.

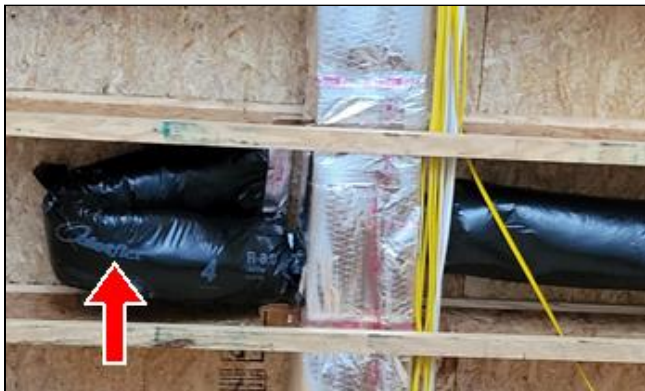
3.1 Item 1(Picture)

**3.1** A HVAC supply duct in the main floor ceiling is improperly bent. Supply vents bent more then 90 degrees have potential to effect proper air flow. Recommend licensed HVAC contractor repair.
