Inspection Report

123 Hokie Ave
Virginia Tech MD

Viking Inspections

Type of building: Single Family (2 story w/ basement)	In Attendance: Buyer and Buyers Agent	Approx. Date of Construction: 1942
Square Footage: 1660	Occupancy: Vacant	Temperature: 43 Degrees (F)
Weather: Clear	Ground/Soil surface condition: Dry	Rain in last 3 days: Unknown
Radon Test: Yes	Water Test: No

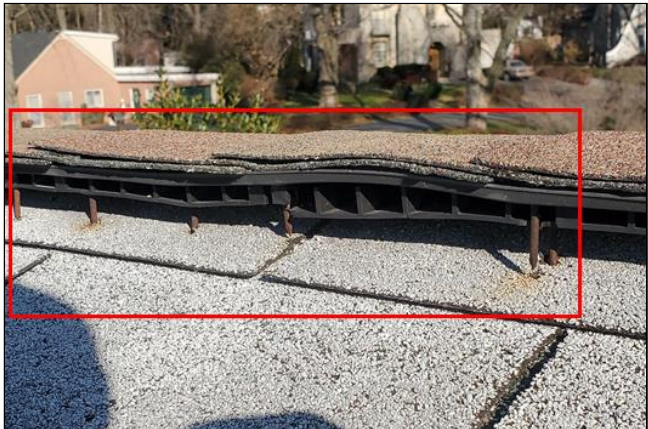
9.3 Item 2(Picture)

- (1) There is a damaged roof shingle and hole in the roof at the ridge next to the chimney. Recommend licensed roofer evaluate and repair/replace as needed.

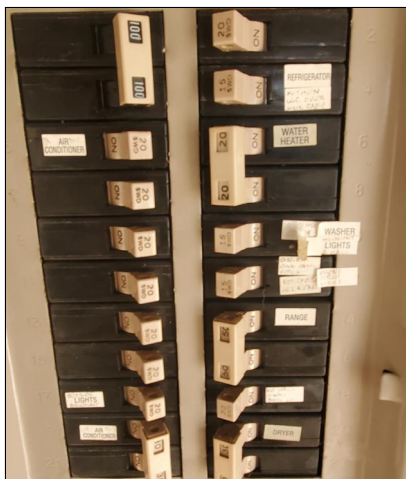
2.1 Item 2(Picture)

- (1) The main electrical service panel is located on the back exterior of the home. Common for date of construction. Recommend panel be relocated inside upon replacement.
- (2) The main electrical service panel schedule is incomplete, not all breakers are labeled. Recommend all breakers be labeled.
